TITLE: Recognition and Correction of Sonic Fatigue Damage in Fighter Aircraft

Recognition and Correction of Sonic Fatigue Damage in Fighter Aircraft

Mr. Salvatore L. Liguore, Dr. Theodor H. Beier

The Boeing Company, PO Box 516

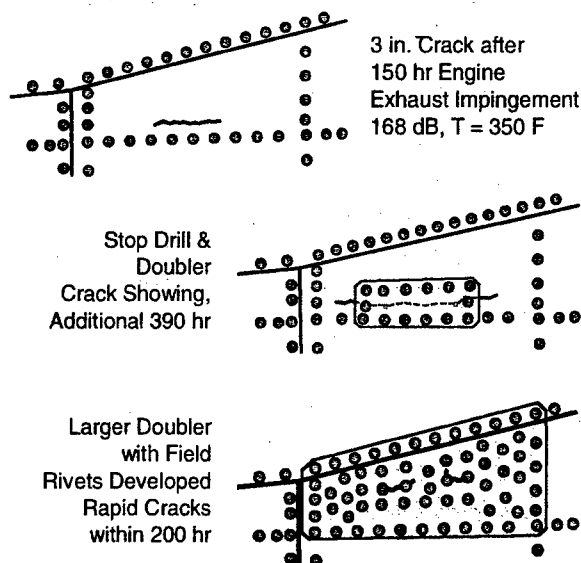
(2) A small fuselage skin panel, Figure 2, incident to the engine exhaust plume exhibited cracks after 150 hr. The cracks were stop drilled and small riveted doublers were applied. Within another 200 hr the cracks were appearing from beneath the doublers. Other aircraft were repaired with larger riveted doublers containing a myriad of "field rivets." In a short time cracks began to occur in the doublers at the rivets. This example typifies the inability of mechanically fastened doublers to arrest sonic fatigue cracking.

Figure 2. Failed Traditional Sonic Fatigue Repairs

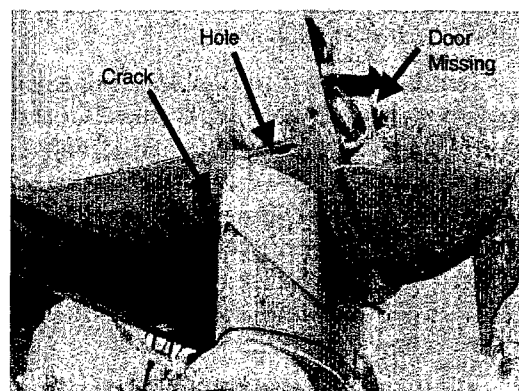
(3) After installation of a blunt ended pod beneath the fuselage, aircraft began suffering skin cracking and door damage after high Q sorties. After one particularly demanding occurrence, an aircraft returned with the damage shown in Figure 3. This is an example of the damage that can be caused by turbulent wakes and shocks.

Figure 3. Sonic Damage After Prolonged High Q Flight

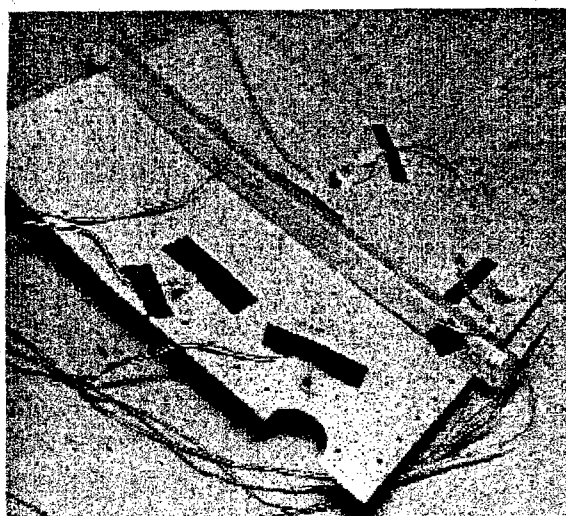
The second demonstration is a lower surface skin panel on the F-15, Figure 8. This panel is part of the lower nacelle skin assembly and experiences high dynamic response during low altitude and high-speed maneuvers. The panel is made of 2024 Al. It is 0.071 inches thick with chem-milled pockets to 0.060 inches and 0.044 inches, and has experienced cracks in the former and in the panel chem-mill boundary. According to Figure 5, this panel is a good example of how a doubler could aggravate the problem if not properly designed to lower loads at the panel edge.

Figure 8. Lower Nacelle Skin Panel Removed from Aircraft Showing the 487.3 Former

The purpose of the damped doubler is to reduce loads in the skin and in the former through damping. The design was verified through finite element analysis. The damping performance of the patch was determined through modal strain energy analysis¹⁴. The panel was analyzed using random response analysis to determine overall RMS loads reduction, Figure 9. The contour plot shows how the stresses in the skin panel are expected to change. Large reductions are expected in the skin panel with smaller reductions at the edges. The modal damping predicted by the analysis was on the average of $\zeta = 5\%$ for the lowest 5 modes at the temperature of interest, which is an increase of over 4.

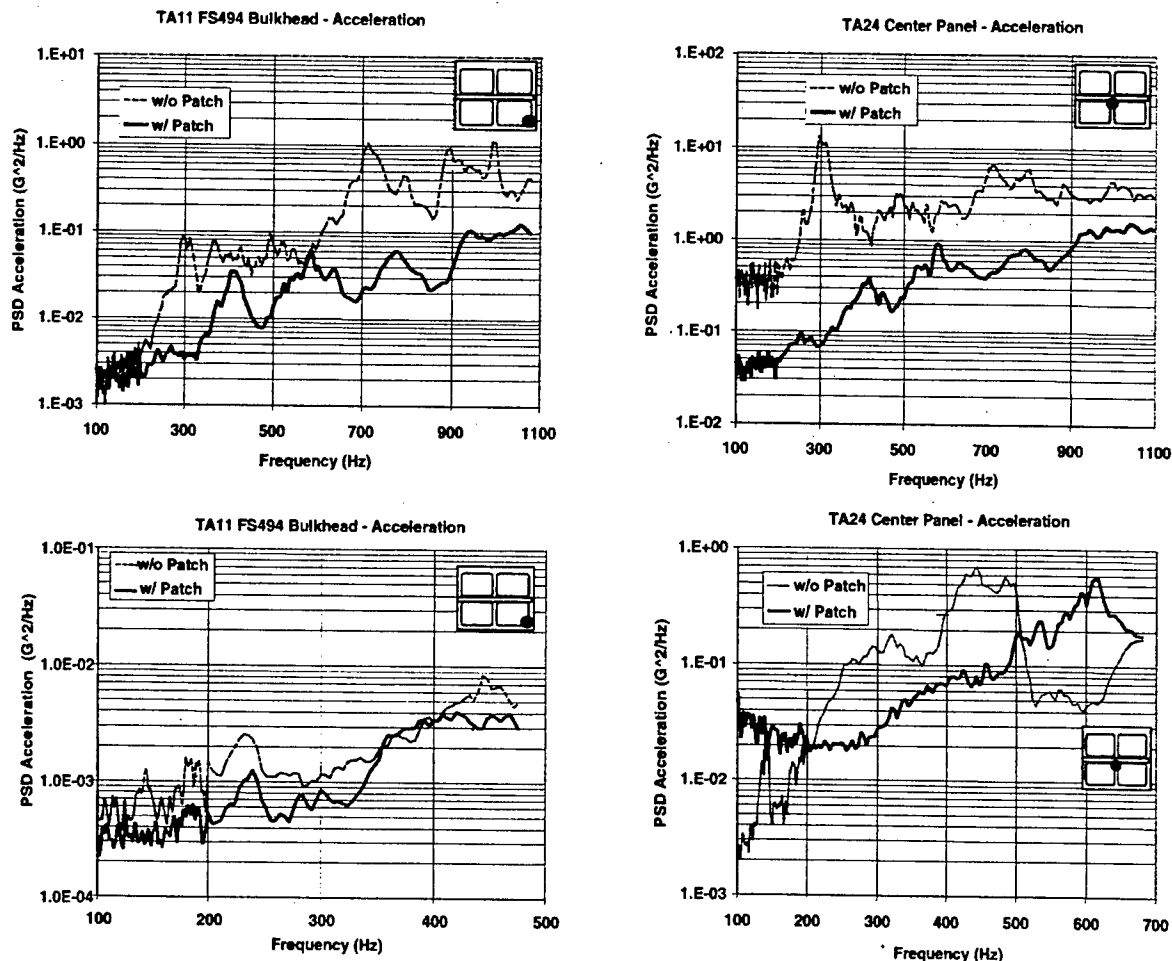
Figure 11. Comparison of Acceleration PSDs w/ and w/o Patch

For the clean aircraft (w/o stores) configuration, the center-panel response drops dramatically with the damped patch. The loads going into the bulkhead to which the panel attaches at FS 494.7 are noticeably reduced at the frequencies corresponding to the panel modes. Similarly, for the w/ stores configuration, the center-panel response drops dramatically with the damped patch. The loads going into the bulkhead to which the panel attaches at FS 494.7 are noticeably reduced at the frequency corresponding to the panel modes. On a closer examination, the RMS values for different frequency bands is listed in Figure 12. Note that better response reduction occurs in the 200 to 1000 Hz band than in the overall.
